# NuSol

## Capacity Fund

**REPORT** | Rural Electrification Program Evaluation  
**SITE** | Nueva Unión, Peru  
**PUBLICATION DATE** | Fall 2011

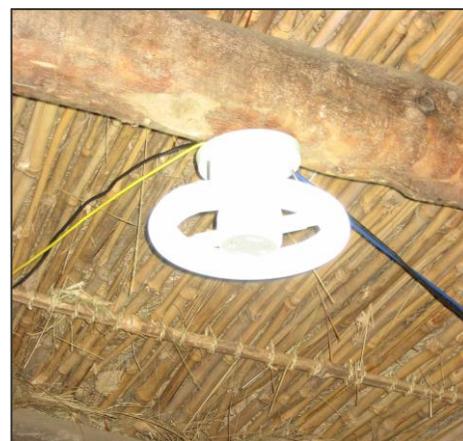
- Prior to the solar electric generating system's installation, there was no electricity within the community medical post.
- The medical post is now equipped with a 20W fluorescent light and one electrical plug-in.
- While the medical post is now capable of operating auxiliary electrical equipment, due to financial limitations within the community and lack of governmental support, the post remains absent of any medical equipment that requires electricity.
- During the site visit, the community's medical technician mentioned the post could benefit from the use of a computer and refrigerator/freezer.

The lighting installed in the medical post
